MEXICO DSA

Conservation + Sustainability

2019

The Earthquake of September 2017: Damages, Diagnosis and Rehabilitation Criteria for Heritage Buildings

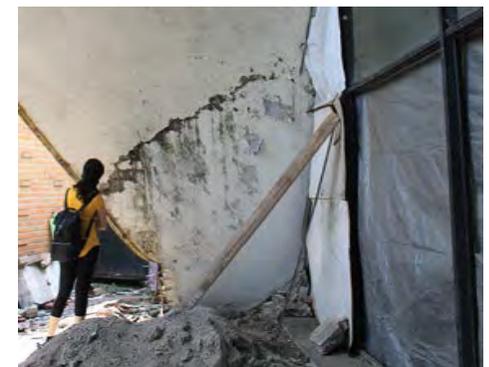
Damages to Los Manantiales following the 2017 earthquake.

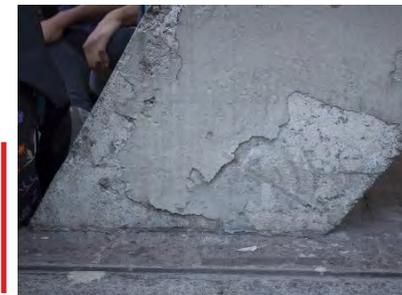
Plaster Spalling

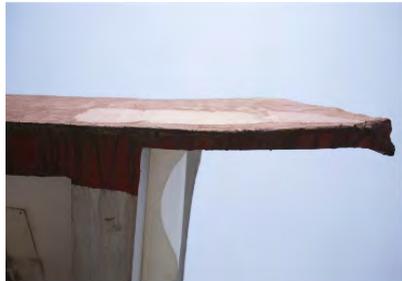
Plaster Spalling

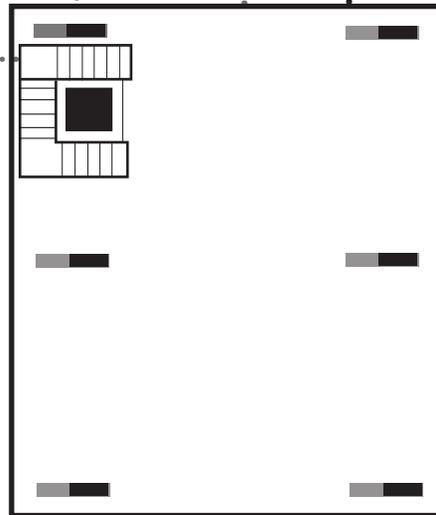
Ground level key plan 1:100
Drawn by Mary Hanna

Plaster conditions, although sparse, are severe in regards to the functionality of the building. Chipped/ spalled areas ruins the aesthetic of the building and impede on its heritage value. In addition, the plaster is used as a membrane to protect the structural components of the Pavilion. The deteriorating plaster occurs on the exterior of the structure and is due to its exposure to natural elements such as moisture.

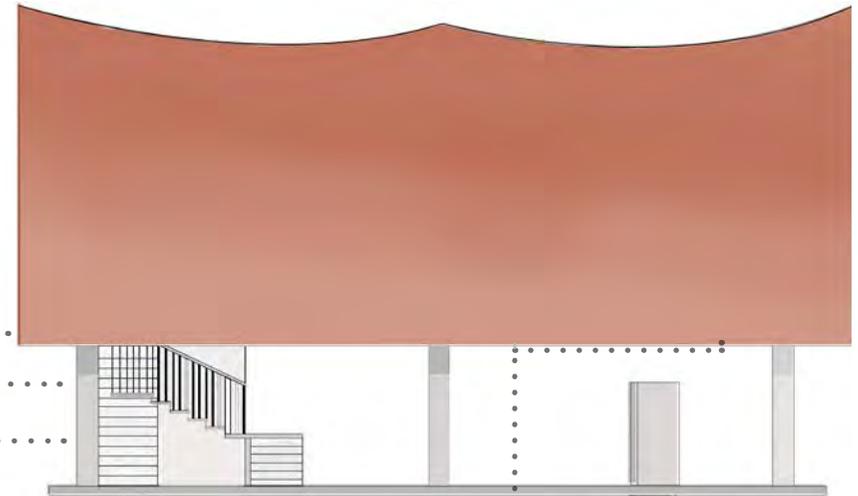
West Elevation
Drawn by Mary Hanna

Concrete conditions are severe in regards to the functionality of the building. Graffiti ruins the aesthetic of the building and impede on its heritage value. In addition, there are reinforcement corrosion cracks and if not treated as soon as possible, they may result in structural failure as well as spalling which is the result of excess water which causes the concrete to flake and break off. Causes of these conditions are mainly due to human interactions in addition to moisture penetration.

The metal elements present within the Pavilion are the railings of the stairs that are safety purposes and the vent. The corrosion that is present on the metals are the result of exposure to air and moisture. Where corrosion is present, it is recommended that proper treatment of these members is undertaken to protect the oxidation from further weakening metal elements.

Reinforcement corrosion crack

Metal Oxidation
Surface level exposure of a member to air and moisture

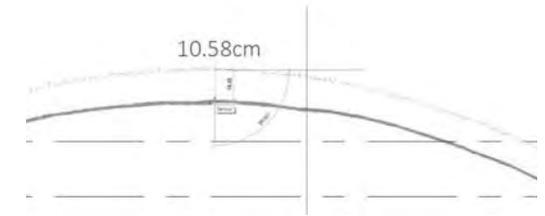
These discoveries could not have been possible solely through the use of traditional documentation techniques. Subsequent studies of the model revealed that the size of this gap varies throughout the entirety of the pavilion and is at its greatest in centre of the pavilion.

Gap between concrete shell and roof membrane.

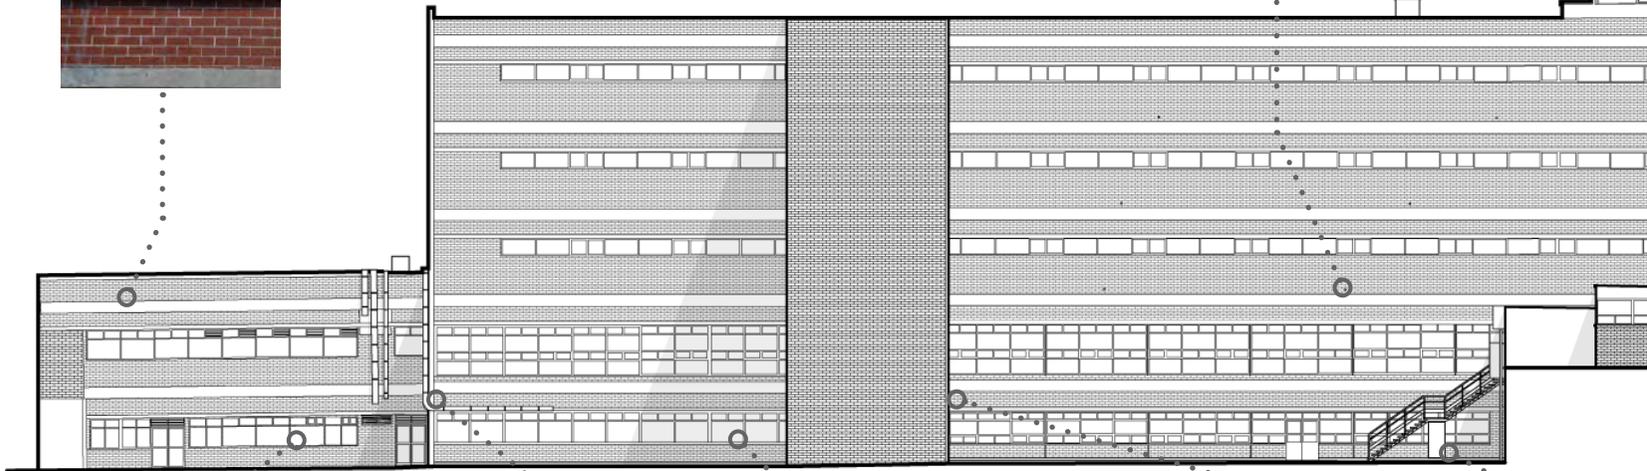
1:400 Drawn by Jessica Babe

Moderate
Surface staining and mortar loss due to improper drainage detail.

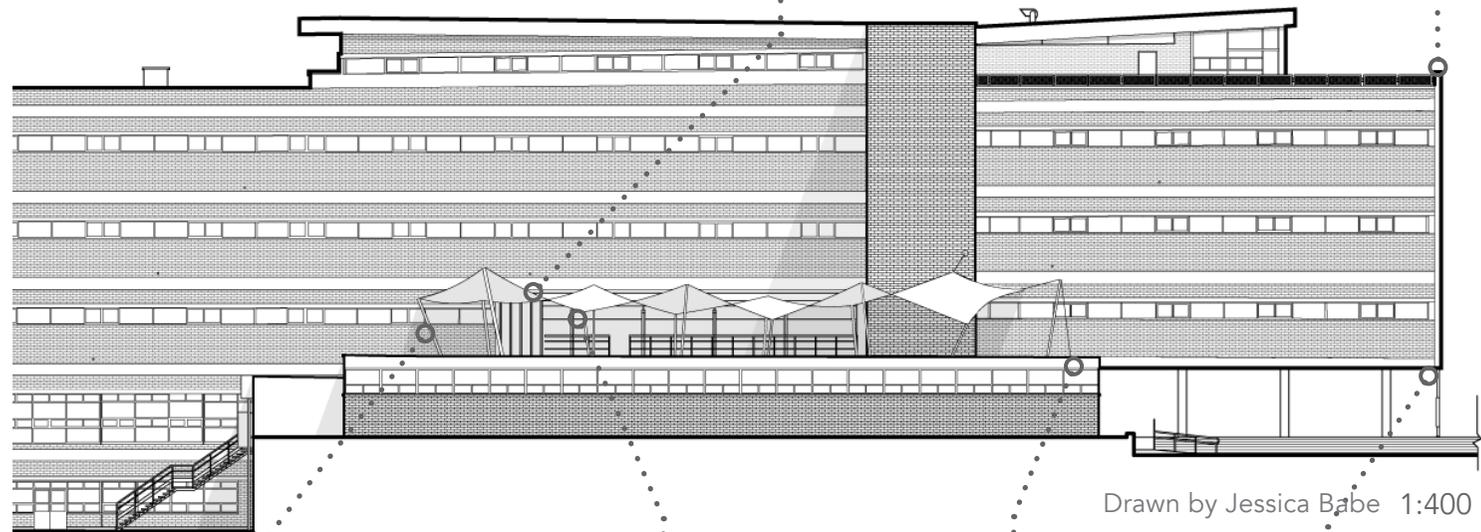
Drawn by Jessica Babe 1:400

Moderate
Hair cracking and delamination of cement parging due to sun exposure.

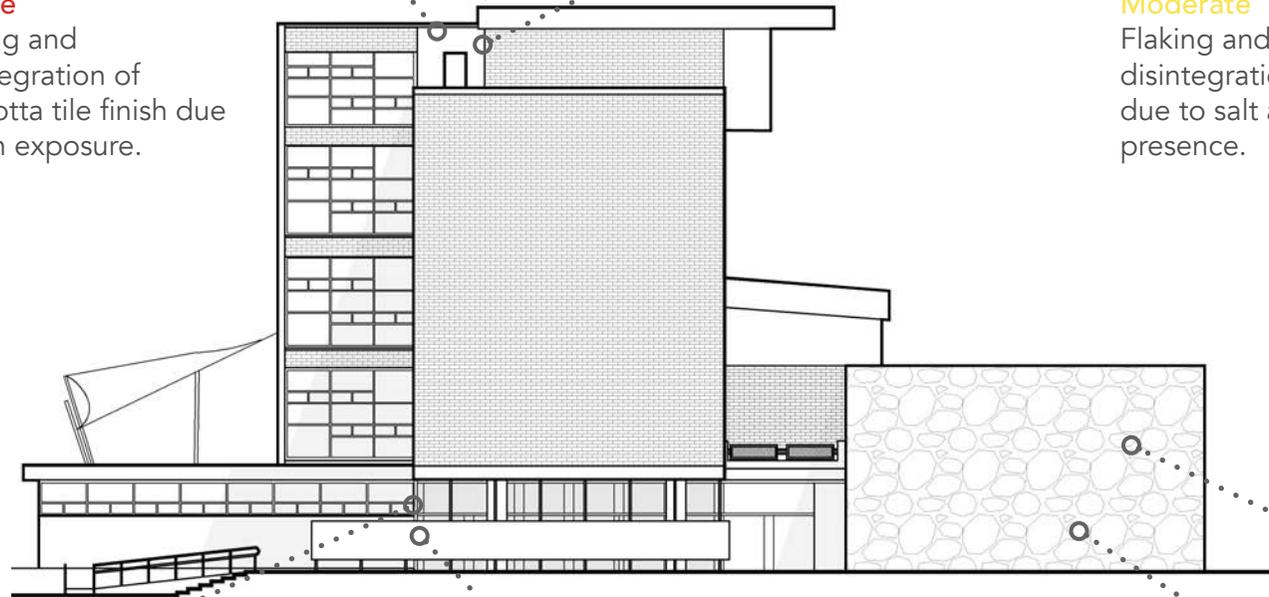
1:300 Drawn by Jessica Babe

Moderate
Flaking and disintegration of bricks due to salt and moisture presence.

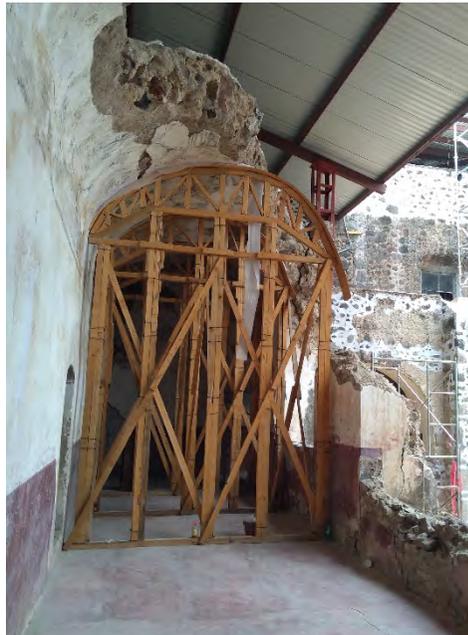
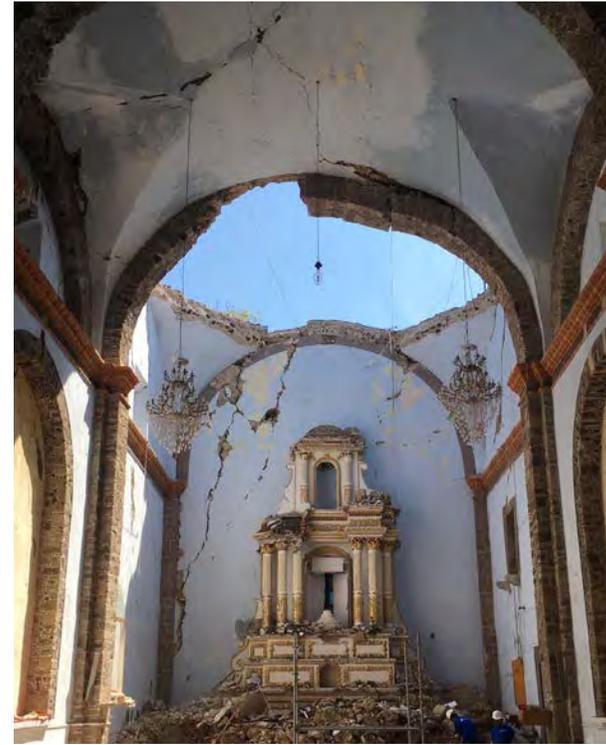
The students observed how the barrel vaults of the church experienced significant cracking and fracturing. Part of the bell tower collapsed. The pendentive dome completely failed during the earthquake, shearing where the vault is the thinnest. The damage to the cloister includes significant fracturing of the barrel vault roofs, cracking of the walls and failure of many of the buttresses in the courtyard. At the east and west side of the courtyard, the barrel vault roofs had collapsed. These recent events prove that it is critical to evaluate the current state of built heritage in order to be better prepared for future earthquake disasters.
