MEXICO DSA

Conservation + Sustainability

2019

The Earthquake of September 2017: Damages, Diagnosis and Rehabilitation Criteria for Heritage Buildings

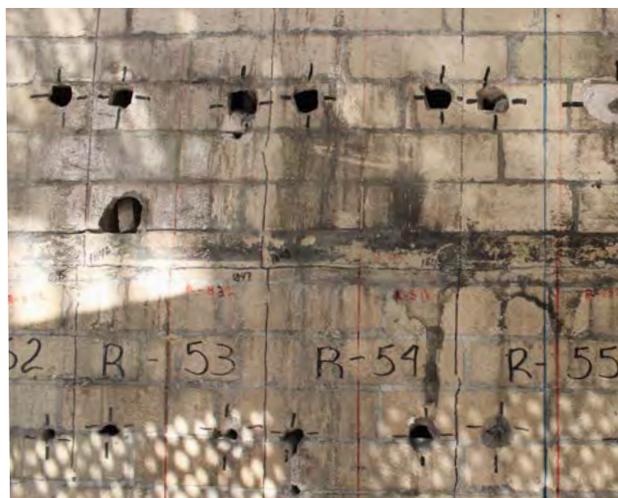
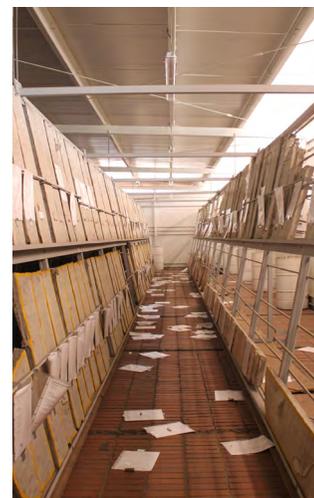
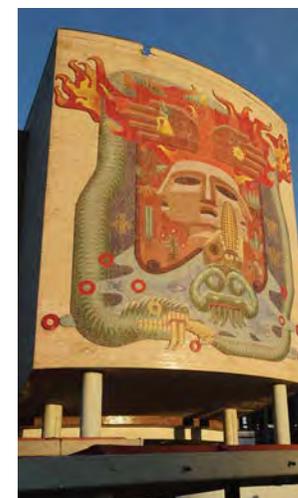
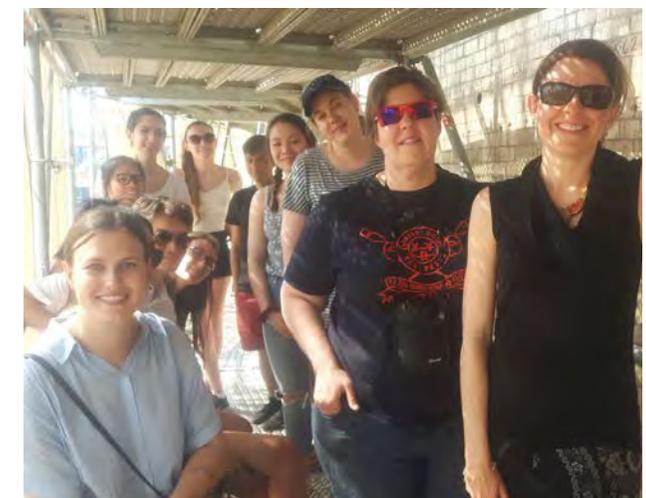
"La vida, la muerte, el mestizaje y los cuatro elementos" / "Life, Death, Miscegenation and the Four Elements"

in sections of precast reinforced concrete slabs and assembled onto the wall to follow the curvature. In 2013, the Institute of Engineering of the UNAM conducted a detailed analysis of the condition of the mural and the wall behind it as a preventive maintenance due to the recurrence of earthquakes in the area. After analyzing the capacity of the original building materials, combined with the fast pace of construction and the related techniques in the Ciudad Universitaria, it was determined that the current structure presented important deterioration and needed an intervention.

The level of damage on the wall was caused by the weight of the concrete pieces that support the mural, the aging of materials and various climate factors. The restoration criteria for the wall consists of reintegrating the structural elements of support by adding materials that are similar to the original ones and that comply with the seismic structural security guidelines. This compliance is crucial to make possible the conservation of the mural as an artistic element integrated with the architecture. The restoration of the wall called for the use of clay bricks (vitro cotta), which were fabricated in the same factory as the one that produced the original materials

This restoration project required the dismantlement of the entire mosaic wall and the numbering and tracking of each individual piece and its original location.

in the 1950s. Multiple colour and texture tests were completed to achieve a similar appearance in the reconstruction of the convex-shaped wall. As part of a larger context, this intervention along with other conservation works in the central campus have a common objective to guarantee the security of structures that are vulnerable to seismic events, as well as to preserve the "Outstanding Universal Value" of this World Heritage Site.

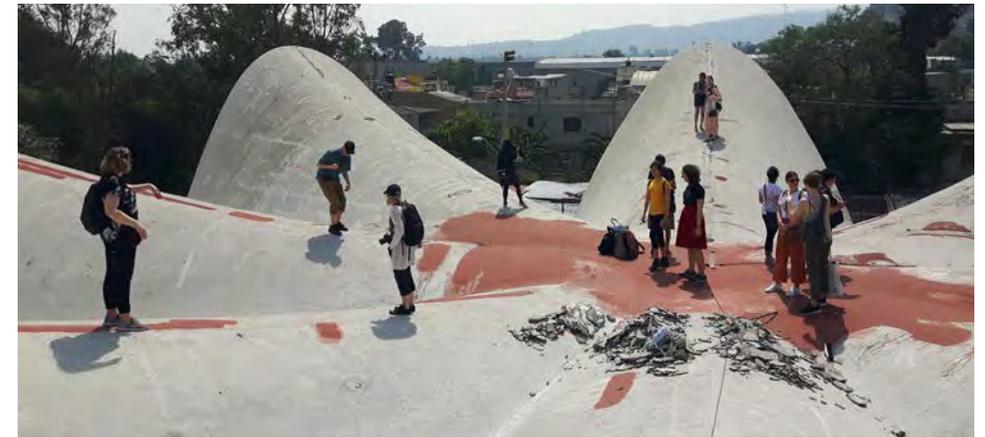
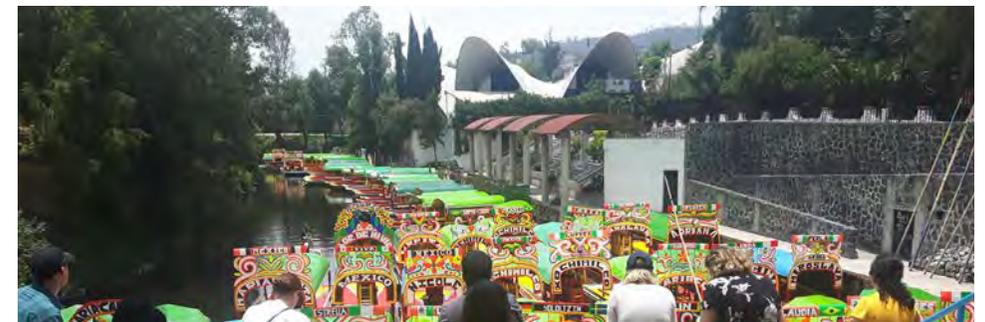
Conservation and Sustainability students observed the damages that the earthquake and the differential settlements next to the lake had caused to the foundation fracture in one section of the perimeter. This displacement created deformations in the geometry of the superstructure.

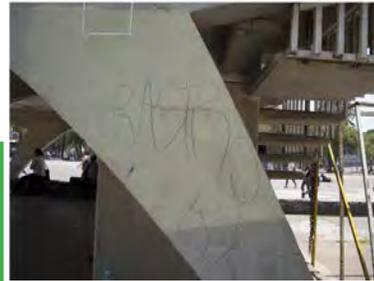
Vandalism on plaster

Plaster conditions, although sparse, are severe in regards to the functionality of the building. Chipped/ spalled areas ruins the aesthetic of the building and impede on its heritage value. In addition, the plaster is used as a membrane to protect the structural components of the Pavilion. The deteriorating plaster occurs on the exterior of the structure and is due to its exposure to natural elements such as moisture.

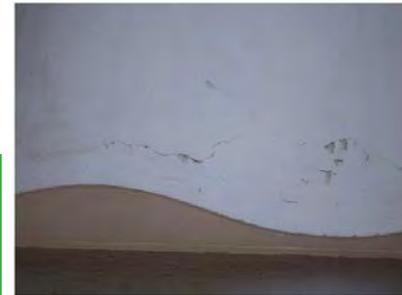
Flaking Plaster

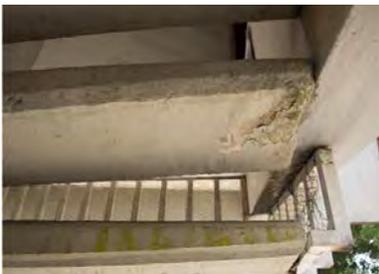
Moisture and Staining of Plaster

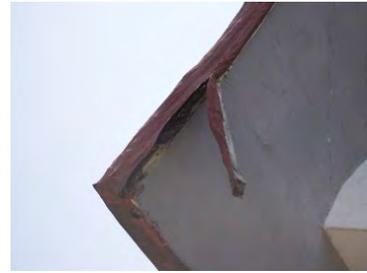
Profile Detachment

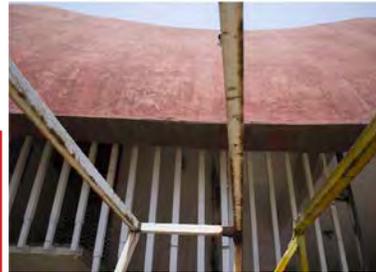
Metal Oxidation. Surface level exposure of member to air and moisture.

The metal elements present within the Pavilion are the railings of the stairs that are safety purposes and the vent. The corrosion that is present on the metals are the result of exposure to air and moisture. Where corrosion is present, it is recommended that proper treatment of these members is undertaken to protect the oxidation from further weakening metal elements.

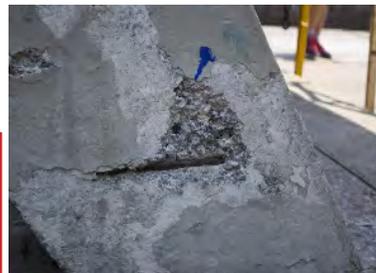
Concrete Spalling: exposed rebar

Concrete conditions are severe in regards to the functionality of the building. Graffiti ruins the aesthetic of the building and impede on its heritage value. In addition, there are reinforcement corrosion cracks and if not treated as soon as possible, they may result in structural failure as well as spalling which is the result of excess water which causes the concrete to flake and break off. Causes of these conditions are mainly due to human interactions in addition to moisture penetration.

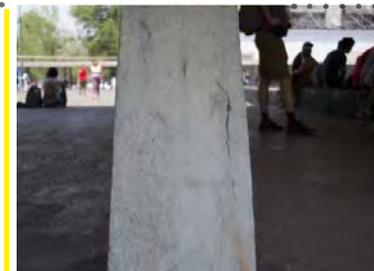
Reinforcement corrosion crack

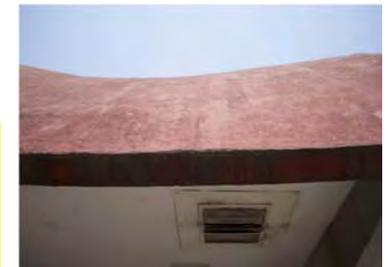
Metal Oxidation
Surface level exposure of a member to air and moisture

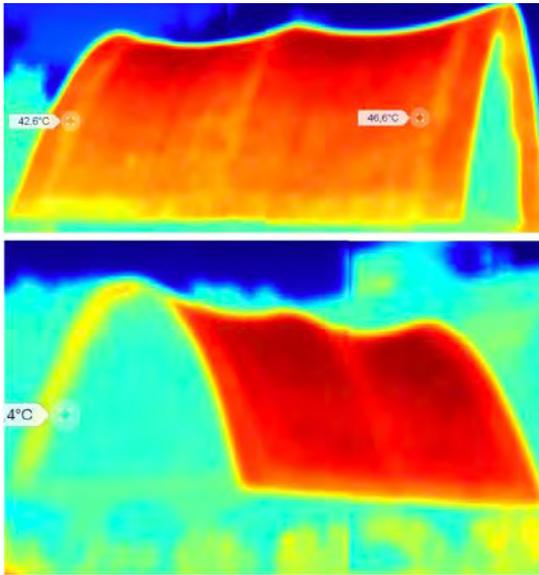
Even temperature distribution across the exterior surface of the pavilion.

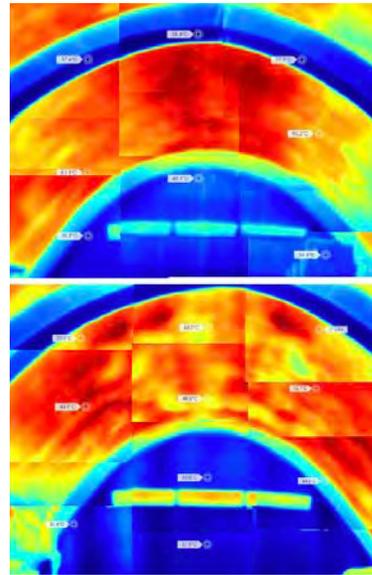
Uneven temperature distribution across the interior surface.

temperature distribution across the interior face of the concrete shell suggesting the presence of pockets of water on the concrete shell itself. This evidence therefore supports the theory that the separation of the roof membrane was likely caused by inadequate maintenance of the membrane layers.

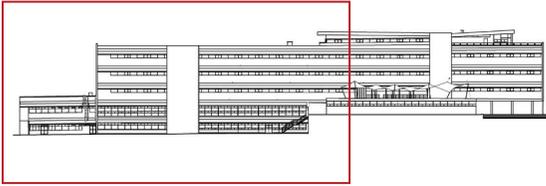
North Elevation

Low
Surface staining and discolouration due to moisture build-up

Moderate
Surface staining and mortar loss due to improper drainage detail.

Severe
Cracking and material loss of concrete sill and exposure of rebar due to corrosion of metal.

Severe
Cracking in wall tiles and replacement of damaged tile with new material.

Severe
Oxidation of metal window frame due to moisture presence.

Moderate
Cosmetic surface cracking.

Severe
Biological growth due to moisture presence.

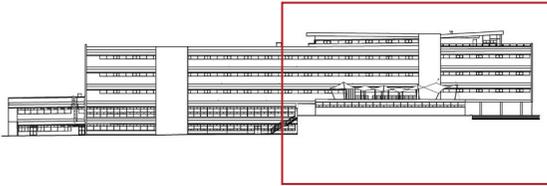
North Elevation

Metal Mullions + Frames

Metal mullions and frames are a very predominant aesthetic feature visible from both the interior and exterior spaces of the building. However, many of the original mullions show evidence of extensive deterioration that has occurred over time which can largely be attributed to moisture presence. This deterioration ranges from mild rust staining to areas with severe signs of corrosion of the metal mullions as well as other metal connections and fasteners. Many severe areas of oxidation are located on the north facade and throughout the basement level. Some mullions have also been replaced in recent years and are identified by a lighter shade of yellow.

Moderate
Patch repair of canvas cover following previous physical damage.

Moderate
Hair cracking and delamination of cement parging due to sun exposure.

Low
Surface level oxidation of metal supports due to exposure to air and moisture.

Severe
Oxidization due to exposure to air and moisture without proper maintenance.

Moderate
Peeling paint and discolouration due to moisture infiltration.

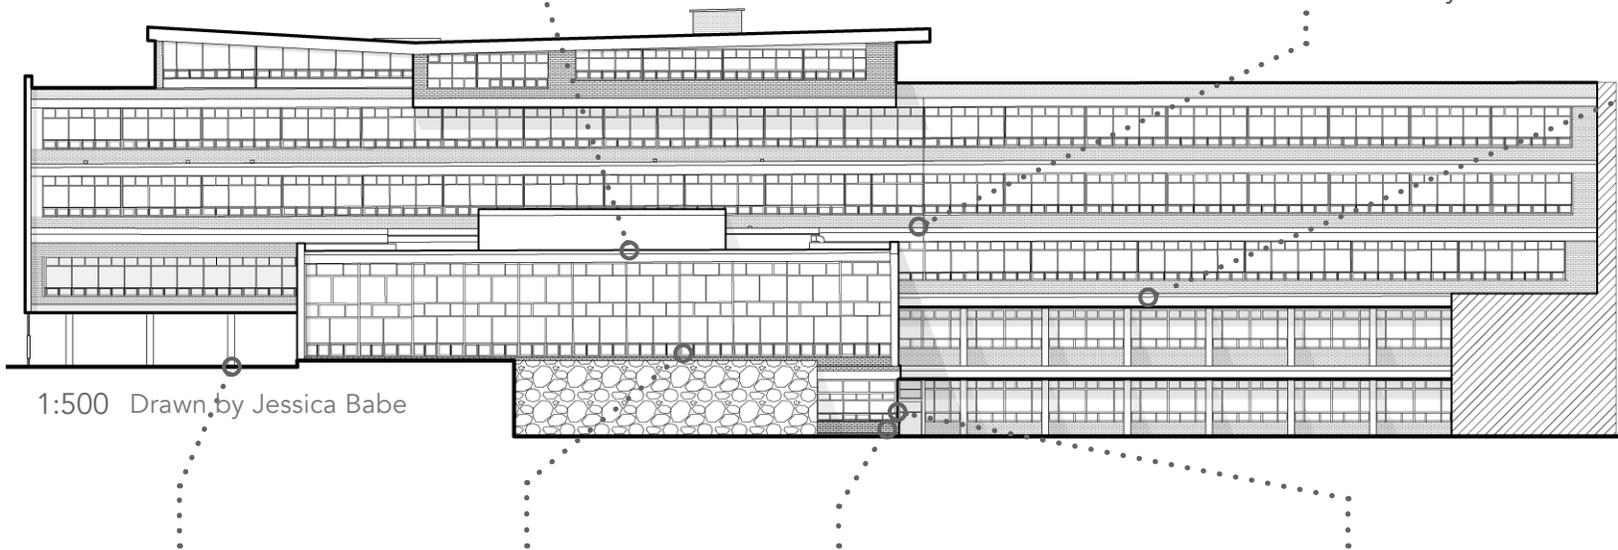
Severe
Discolouration, cracking and material loss of concrete panels due to moisture infiltration.

Moderate
Discolouration due to salt deposits on the concrete surface.

Material loss is the most prevalent form of deterioration of new and character-defining original wall tiles. The application of opaque substances, the intrusion of metal rods into tile-covered columns and walls, as well as minimal cracking and grout failure have been observed throughout the entirety of the building. Deterioration is more prevalent within the newer tiles applied in sheets than in the original hand installed tiles. None of the above deteriorations are structural issues, but given the fact that the green wall tiles are character-defining elements of the building, their deterioration and lack of repair means a diminishment of architectural character.

Severe
Salt crust due to wetting and drying cycles of moisture produced by HVAC equipment.

Moderate
Material loss of original *Vitricotta* tile repaired with concrete infill.

Severe
Deep cracking along concrete sill potentially due to seismic activity.

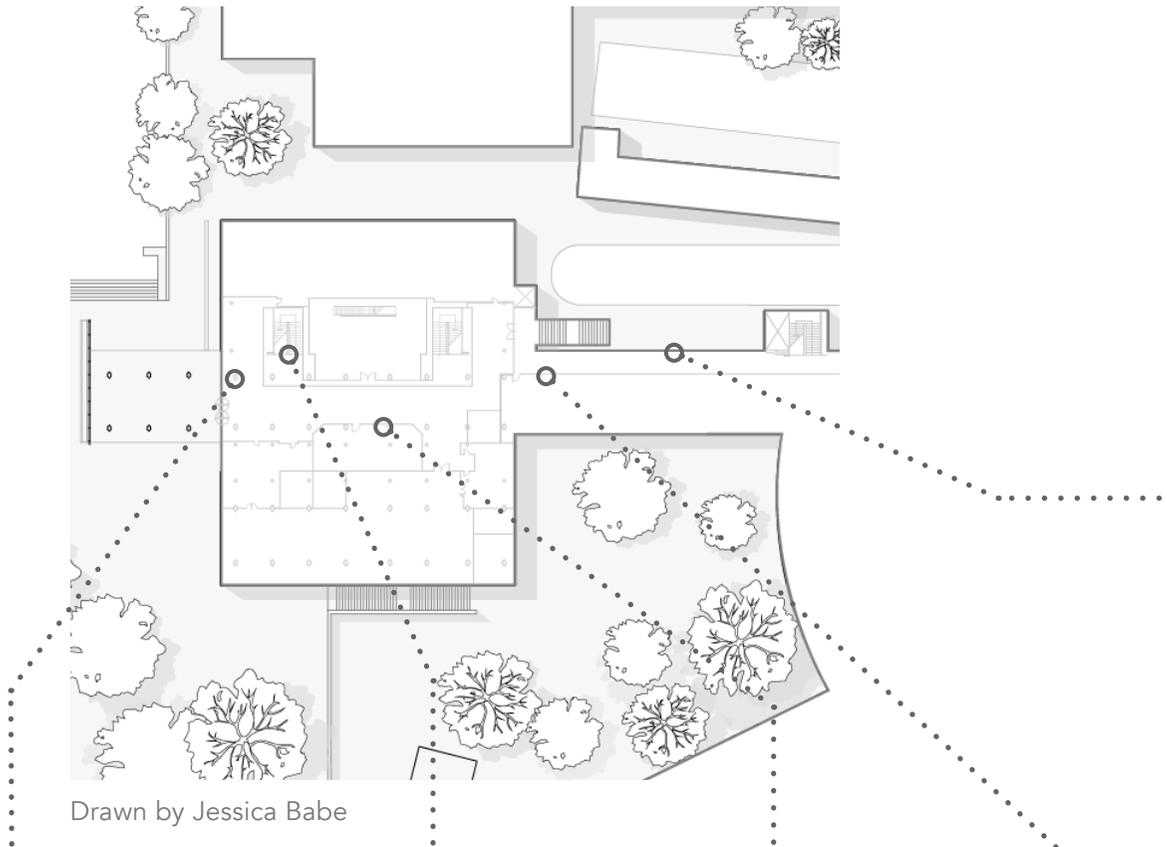
Ground Floor

A condition assessment of the interior of the building was conducted and has identified several reoccurring forms of material deterioration. Natural deterioration patterns such as material loss, cracking, discolouration and oxidation are typical for all interior levels. Deterioration due to anthropogenic causes such as patch repairs and improper construction details are also common. Both the natural deterioration and human interventions have had an impact on the architectural character of some of these interior spaces and may need to be addressed in the near future.

Severe
Material loss and discolouration of metal window frame due to metal oxidation from moisture build-up.

Severe
Material loss of wall tiles around base of columns caused by seismic activity or settlement.

Low
Hair cracking of mortar joints between glass blocks. The blocks themselves are in fair condition.

Moderate
Replacement of vitricotta tiles. Appears to be continuous on all upper floors and aligns with separation of exterior concrete slabs on south elevation.

Severe
Patch repair of missing vitricotta tiles around door frame on typical upper floor using concrete infill. Damage or loss of original tiles likely due to seismic activity.

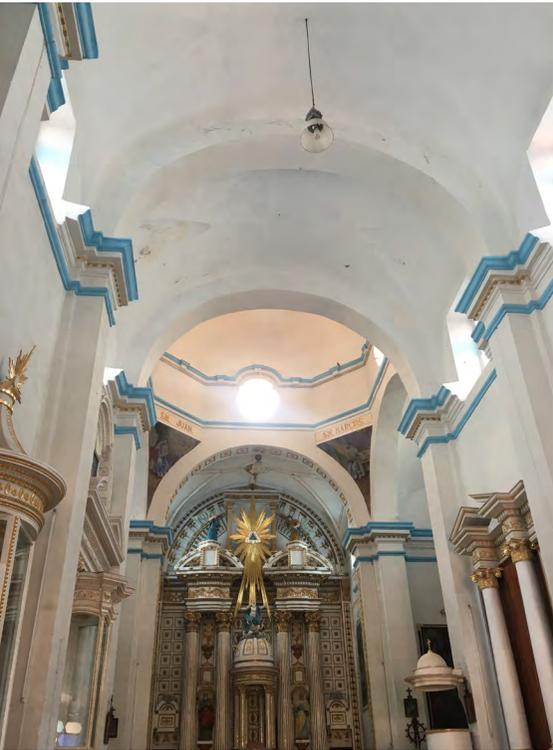
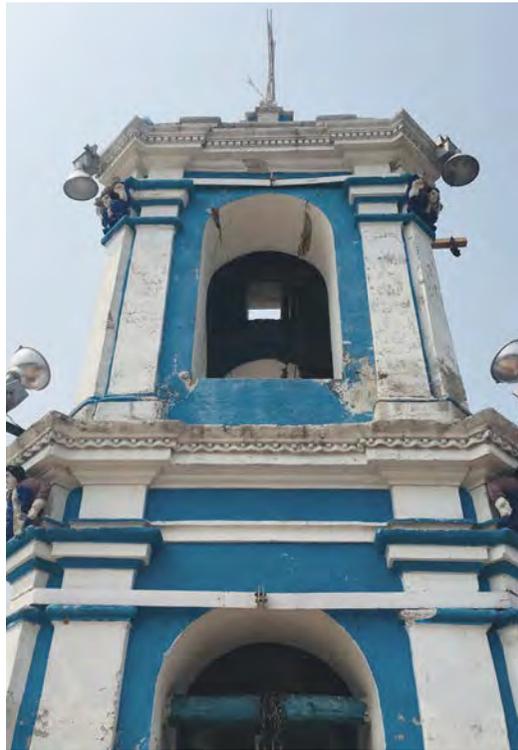
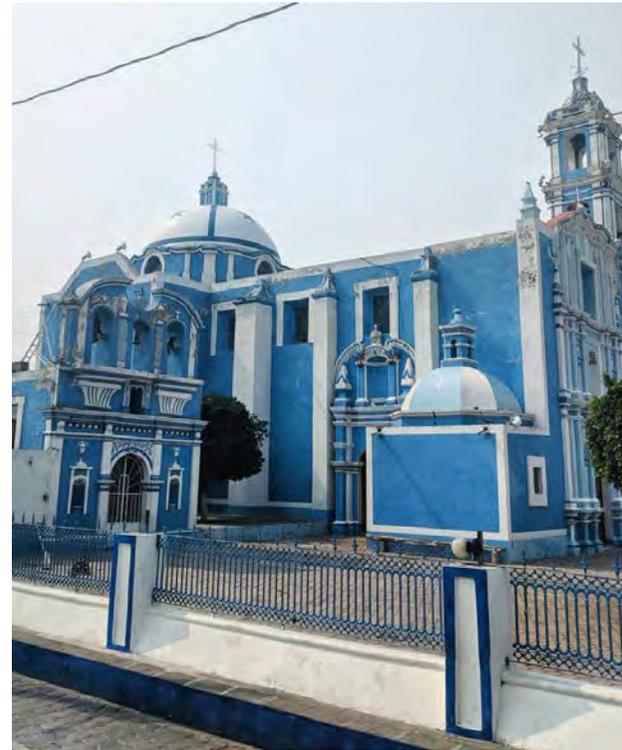
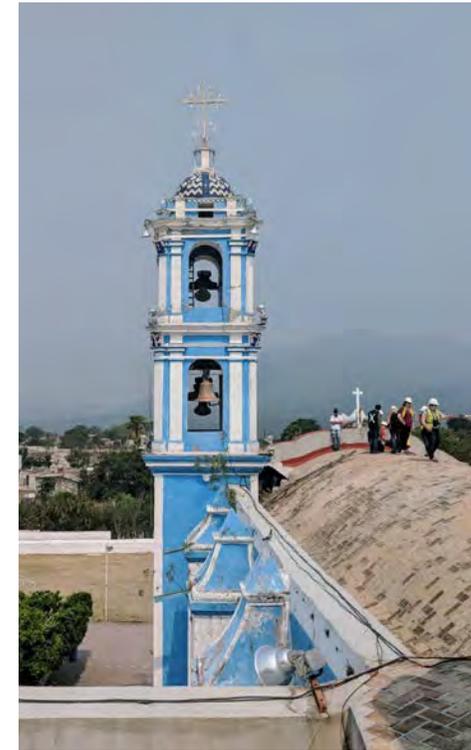
Ex Convento de San Guillermo, Totolapan, Morelos

The former Augustinian Convent was designated as a World Heritage Site in 1994. After it suffered great damage from the 2017 earthquake, the INAH got involved for the restoration of the building. Fernando Duarte, coordinator of Historical Monuments of the INAH Morelos Center, explains that an incompatible intervention

made to the structure about 25 years ago using concrete beams made it behave differently with the oscillation generated by the earthquake. This intervention combined with the lack of maintenance, caused the collapse of the inner part of the vault.

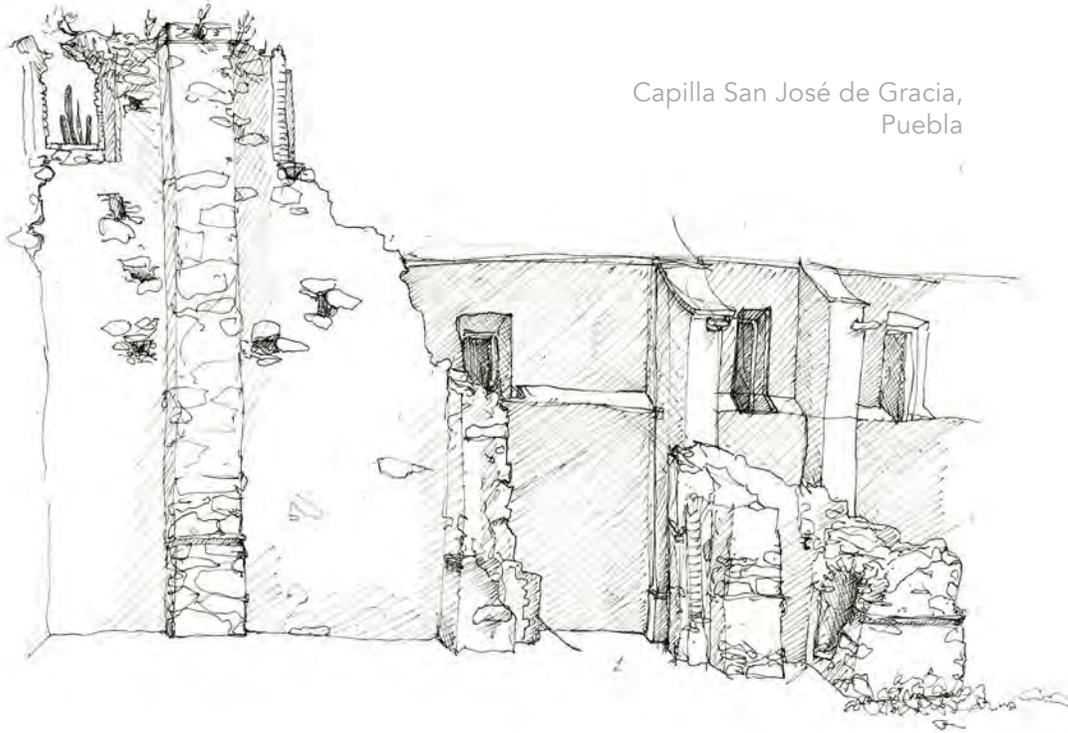
Capilla San José de Gracia,
Puebla

from a Marian advocacy to the worship Saint Joseph. Architects Elisa Vera and Ivan Ríos Peralta from PROSUCO, whom specialize in the conservation of ruins, had been working on the site for 10 months due to its deterioration following the earthquake of 2017.

Their restoration works included the structural separation of the building with the ruin, the recovery of the geometry in the arches along the body of the church, the consolidation of the structure of the walls and maintenance works in vaults to avoid humidity.

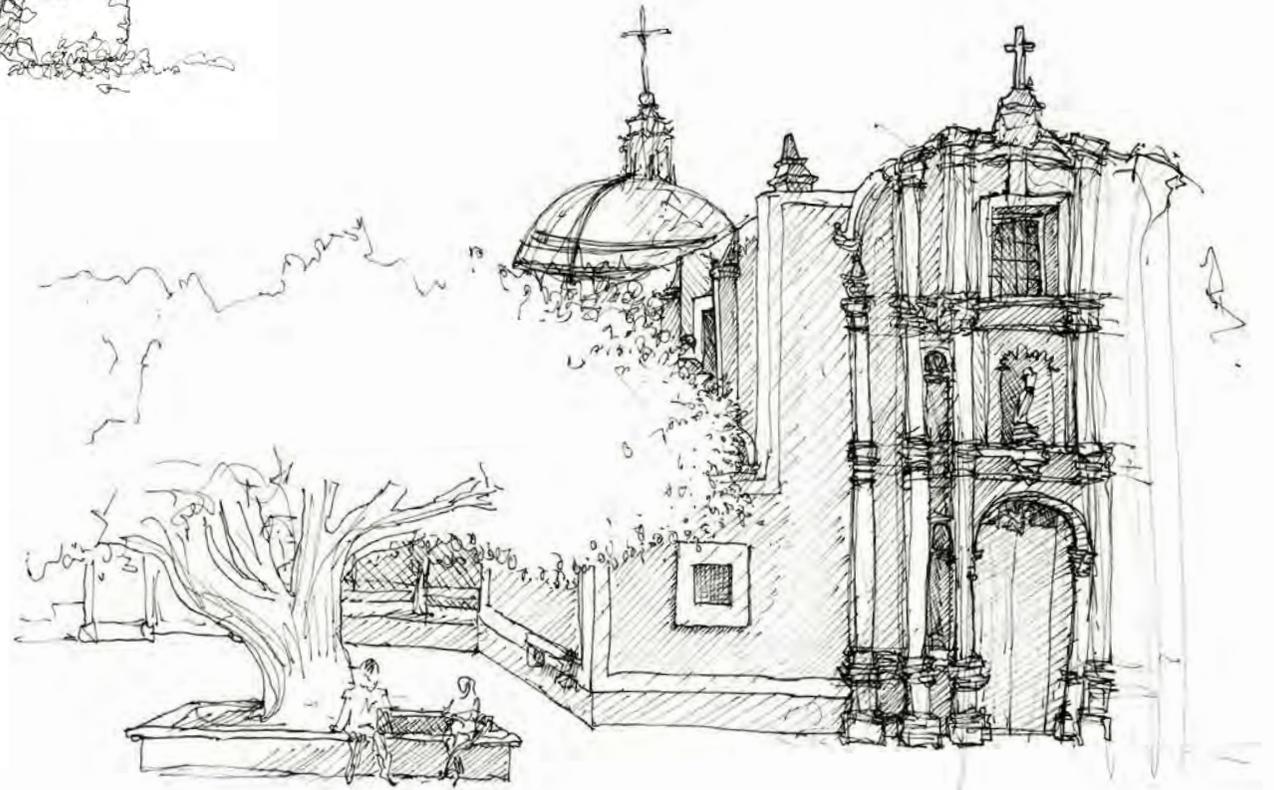
Templo Santa María
de la Asunción
Puebla

1999. After 2017, the tower was damaged by the rigidity of the concrete and, as a result, could not oscillate at the appropriate frequency during the earthquake. The addition of concrete was not suitable to maintain its structural integrity. Cracks occurred in the barrel vault and some of the arches.

presented both minor and high damages. Therefore, the restoration works will be limited to the recovery of ornamental elements and the maintenance of the vaults to avoid humidity accumulation in the walls. The bell tower will be consolidated by injection of mortar into cracks.
